January 19 Earthquake (updated)

NEW - Final Update, February 6, PM

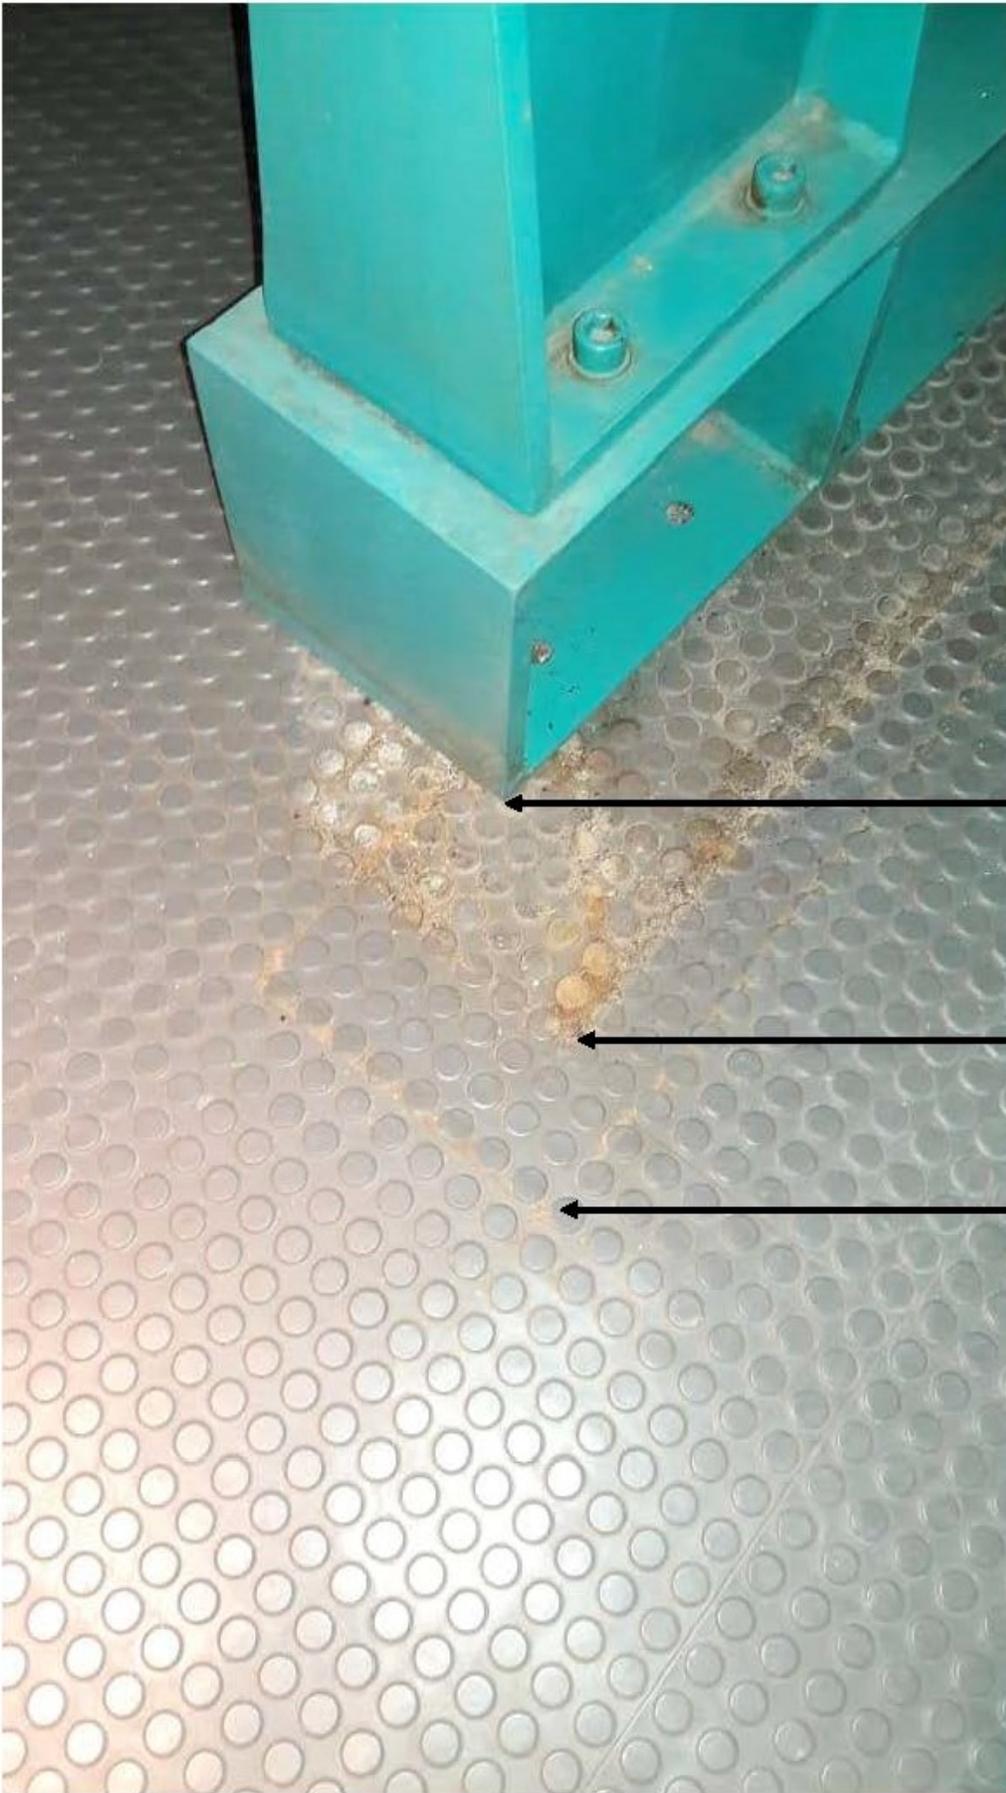
The picture below shows one corner of the boomlift installed on the observing floor; the marks indicate how much the 2015 event and this one have shifted it. The assembly weighs approximately 6 tons.

Position Jan. 20,
2019

Position Sept. 17,
2015

Original position

The movement after each event was approximately 15 cm.

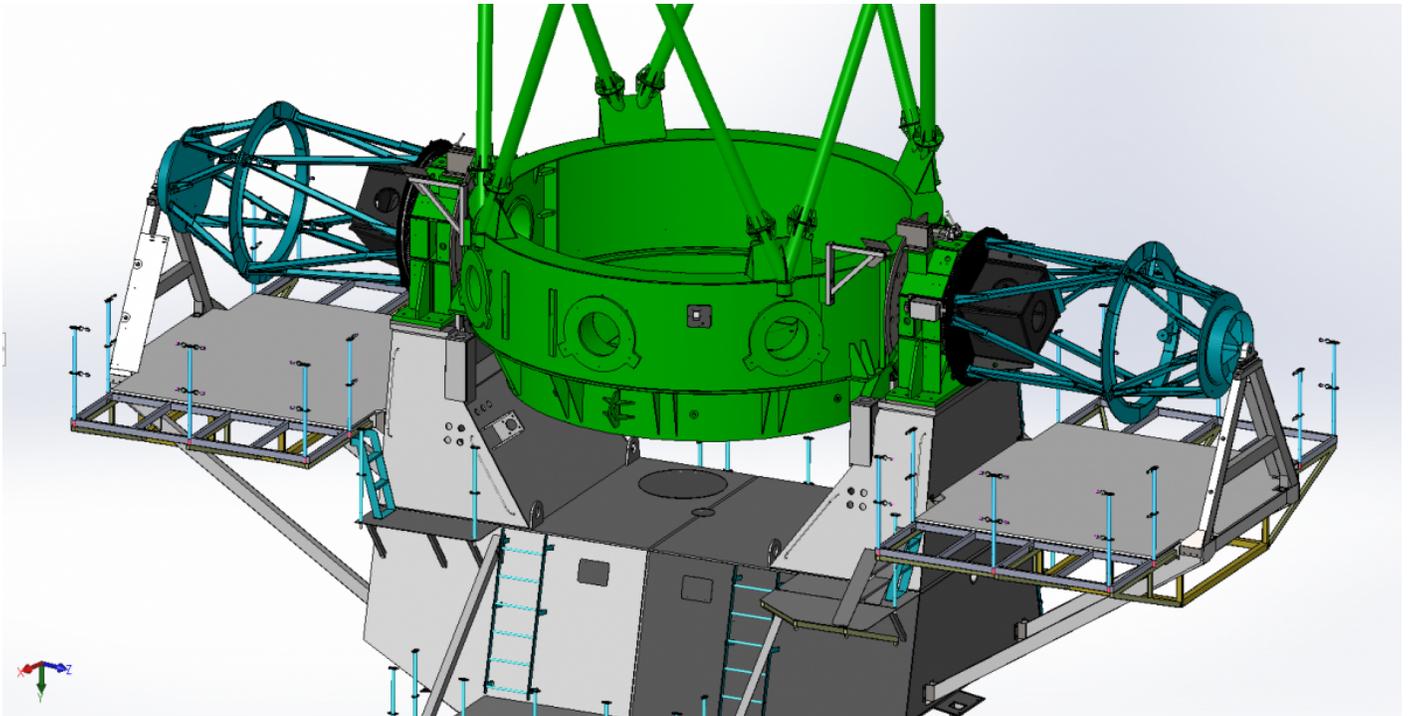
Monday, January 21, the secondary was inspected, removing baffles and shields as required, and found to be OK. However, a complete inspection of the elevation axis and encoders revealed a displacement of the disk with the encoder tape relative to the encoder heads of approximately 2 mm on the IR Nasmyth side, and somewhat less on the optical Nasmyth.

The next day it was confirmed that the entire elevation structure had shifted where it is bolted to the yoke, as indicated by marks in the painted surfaces. There is no apparent damage to the elevation axis itself. Preliminary analysis indicates that, even with the shift, the telescope can be operated safely, once the encoders are re-aligned.

The figure above shows where the displacement occurred - the part in green is what shifted relative to the yoke (Figure courtesy of José Piracés).

Once it was clear what had happened, the crew worked on re-aligning the encoders and recalibrating them. This also included bringing back various sub-systems on the telescope (M2, calibration wavefront sensor). This work was completed January 25, so we are attempted to resume normal operations. Observations over the weekend of the 26th showed that the encoders were not as reliable as expected, so work continued on re-alignment on both axes (azimuth and elevation). On-sky testing was complicated by several nights of high humidity that prevented observing.
