Earthquake Impact at SOAR - updated

Submitted by jelias on Thu, 2015-09-17 16:17

Final update October 3

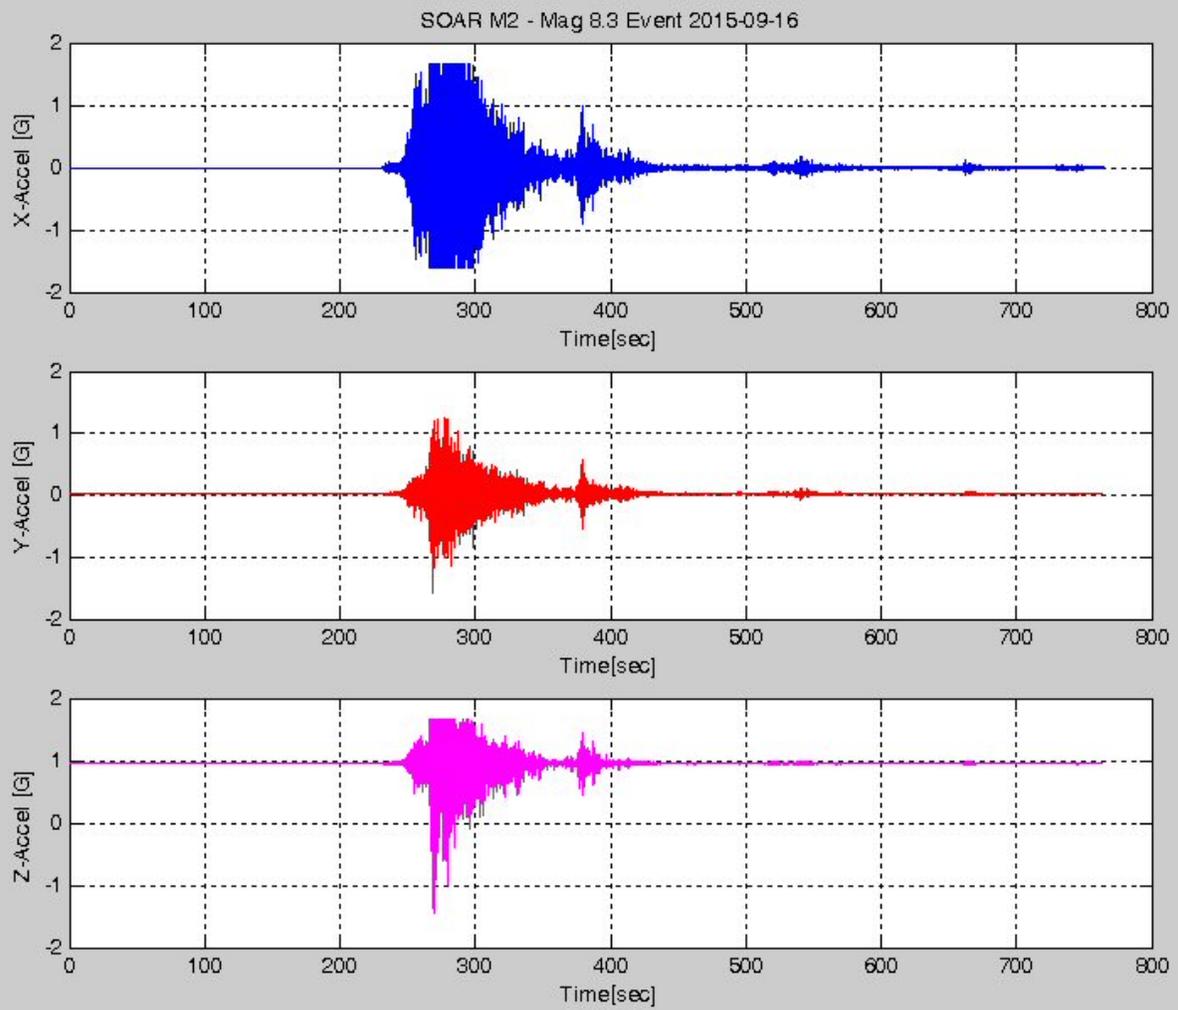
The plots below show the accelerometer readings from the pier and the secondary mirror assembly during the main earthquake event. Analysis is not complete, but results from an earlier event indicate that the amplification from the pier to the secondary can be as large as a factor of 30 at resonant frequencies of the secondary assembly.

Accelerometer readings from SOAR pier (top) and M2 assembly (bottom). Note that the forces exceeded the saturation point on the M2 accelerometer for both the X and Z axes.
